TITAN BUILDING PRODUCTS TEST REPORT

TESTING OF TITAN CEDAR WOODEN GUARD WITH ALUMINUM PICKETS TO ASSESS RESISTANCE TO LOADS ON GUARDS AS PRESCRIBED IN THE 2015 NATIONAL BUILDING CODE OF CANADA (NBC) AND 2012 ONTARIO BUILDING CODE (OBC).

103914490TOR-003

TEST REPORT FOR TITAN BUILDING PRODUCTS

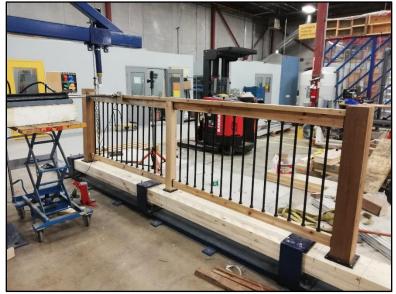
Photo No. 1 Horizontal Top Rail mid-span Load Test

Concentrated test loads were applied separately and sequentially at the following critical locations: horizontally on the top rail at mid-span between posts, horizontally on the top rail adjacent to a post, and horizontally on top of a single post. Specified and factored loads were applied over a 100 mm x 100 mm square platen and held for one (1) minute, whereupon deflection was recorded at the point of application of the load. The load applied on the rail adjacent to the post was applied to the opposite post from which the top-of-post-test was performed on. After release of the load, the system was evaluated for failure, evidence of disengagement and visible cracks in any component.

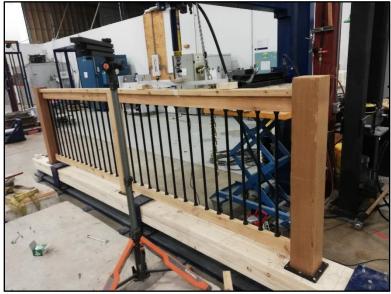
Photo No. 2 Vertical Top Rail ¼ Point Load Test

The top rail was subjected to vertical quarter point loads applied by means of a load distributing bar. Specified and factored loads were applied and held for one (1) minute, whereupon deflection of the top rail at mid-span was recorded. After release of the load, the system was evaluated for failure, evidence of disengagement and visible cracks in any component.
